FINAL REPORT

Eelgrass Mapping Along The Elwha Nearshore

June and September 2006

James G. Norris and Ian E. Fraser

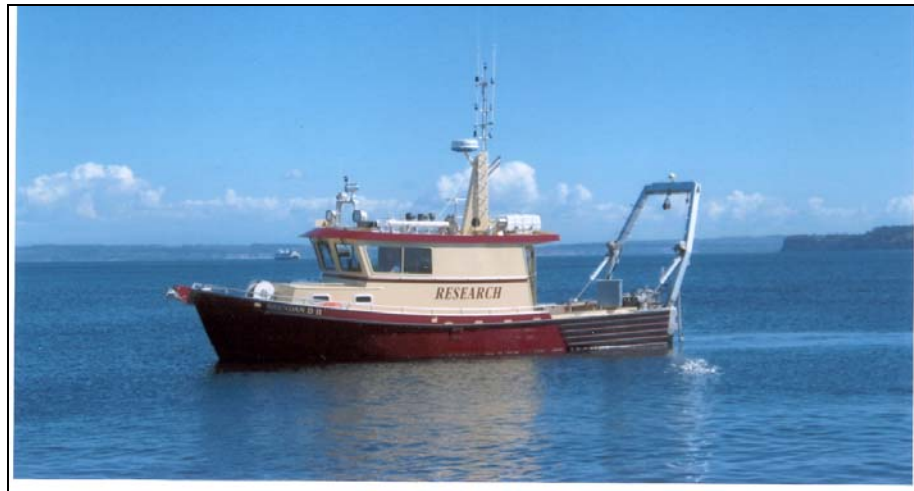
Figure 6. The *R/V Brendan D II*.

We conducted sampling aboard the 36-ft *R/V Brendan D II* (Fig. 6). We acquired position data using a sub-meter differential global positioning system (DGPS) with the antenna located at the tip of the A-frame used to deploy the camera towfish. Differential corrections were received from the United States Coast Guard public DGPS network using the NAD 83 datum. A laptop computer running Hypack Max hydrographic survey software stored position data, depth data from one echosounder (Garmin), and user-supplied transect information onto its hard drive. Position data were stored in both latitude/longitude and State Plane coordinates (Washington North, US Survey Feet). All data were updated at 1 s intervals. Table 2 lists all the equipment used during this survey.

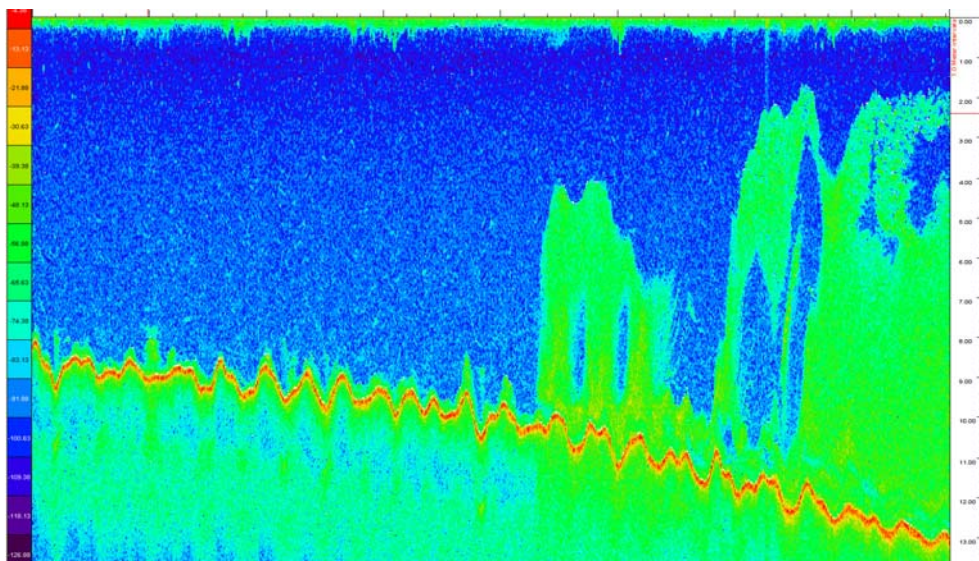
Figure 7. Sample echograph from the BioSonics DE4000 system.

We estimated fish densities (fish per square meter of surface area) using echo integration over 10 second intervals along each transect on which we observed fish. To avoid including surface noise and signals from understory kelp, we eliminated signals within 1 m of the surface and the seabed. Fig. 7 shows a sample echograph with a large school of fish at the deep end of the transect (note: the red line indicates the seabed; the wave pattern of the seabed is due to surface waves—the boat going up and down—and does not represent sand waves).

We used a target strength value of -70.33 dB, as determined for 4.0 cm long fish from the relationship given in Thomas et al. (2002). A histogram of the resulting densities indicated a log distribution (some very high densities and many very low densities), which we divided into three categories—low (< 220 fish/m²), medium (880 – 7,500 fish/m²), and high (> 7,500 fish/m²). We converted density in fish/m² to fish/m³ by dividing fish/m² by the average depth of the associated transect segment. We plotted these three categories on a map and manually created polygons representing the locations of each density category.

We observed fish all along Ediz Hook, with the highest densities along the western deepwater edge of the eelgrass bed (Fig. 14). Lower densities were observed in Freshwater Bay and around Angeles Point. We often observed fish at the deepwater end of our transects (e.g., Fig. 7).

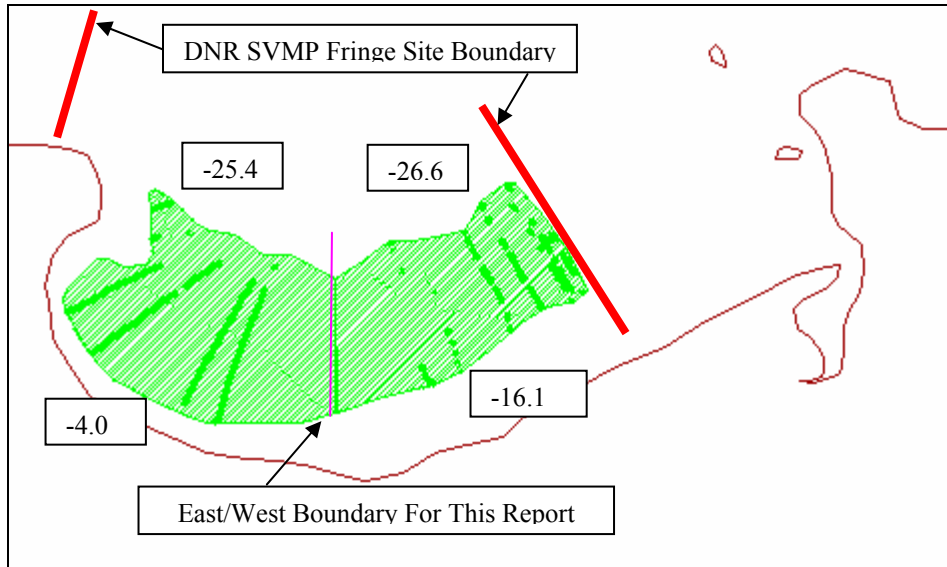
Figure 12. Detail map of the Crescent Bay eelgrass bed.

The west Freshwater Bay eelgrass bed spanned a broad depth range at its west end (-0.6 ft to -21.4 ft), but narrowed at its east end (-11.3 ft to -12.1 ft). The nearshore edge became deeper and the offshore edge became shallower from west to east (Fig. 11). The Crescent Bay eelgrass bed showed a similar pattern for the nearshore edge, but the deepwater edge did not become shallower toward the east (Fig. 12).

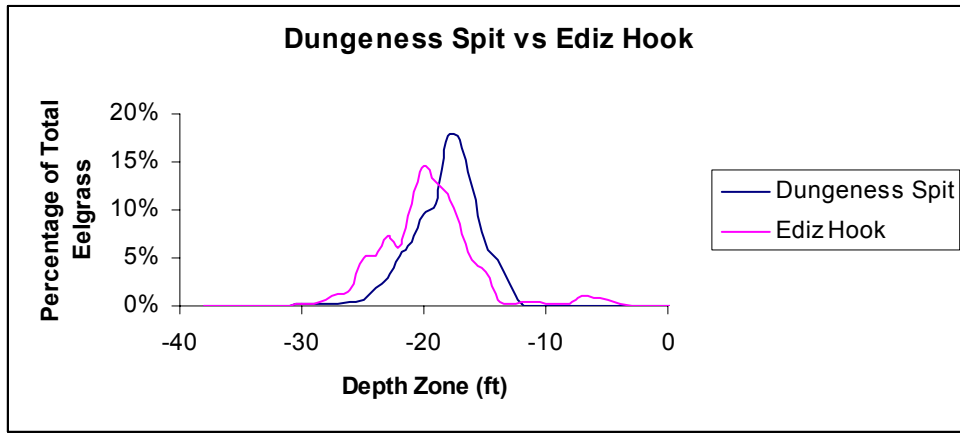
Figure 13. Eelgrass distributions by depth zone for comparable sites within and outside the Elwha drift cell.

Fig. 13 shows the eelgrass distribution by depth for comparable eelgrass beds within and outside the Elwha drift cell. The Ediz Hook and Dungeness Spit beds had very similar distributions, with most eelgrass concentrated between -15 ft and -23 ft. Eelgrass in east Freshwater Bay was concentrated between -9 ft and -18 ft, whereas eelgrass in east Crescent Bay was concentrated between -18 ft and -25 ft. Eelgrass in west Freshwater Bay and west Crescent Bay beds spanned a broad depth range, with more eelgrass between -1 ft and -10 ft than the other beds.

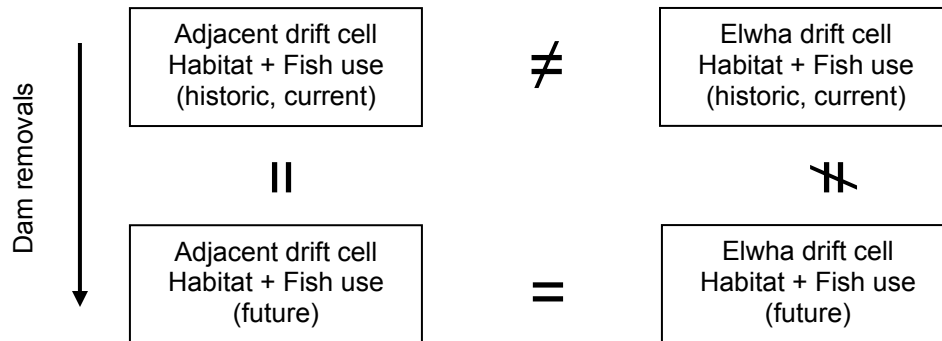
Figure 1. Conceptual model for measuring restoration response to dam removal (from Shaffer et al. 2005).

Approximately 10 million cubic yards of sediment trapped behind the dams will be delivered to the nearshore within five years of dam removal, which is anticipated to be a two year process. Shaffer et al. (2005) developed a conceptual model for measuring the restoration response of nearshore habitats and fish use to dam removal. The model has two components (Fig. 1):

1. Compare post-dam removal nearshore resource and habitat function to pre-dam removal nearshore resource and habitat function;
2. Compare habitat function within Elwha nearshore to comparable nearshore outside the project area.
