Clallam County Marine Resources Committee
January 2026

Goals

In 2023, a first-generation prototype of a small-scale marine current turbine was operated in Sequim Bay, Washington (USA) for 141 days. The system, referred to as the Turbine Lander, was the product of a laboratory-to-field effort to develop a system that enables enhanced ocean sensing or vehicle recharge in remote, energetic settings. The turbine consists of a vertical-axis, cantilevered rotor (1.19 m × 0.85 m) with four foils installed on a gravity foundation. A broader range of constraints including the deployment strategy, site characteristics, and estimated loads, drove the system's design. This work presents the design, characterization, operation, and post-recovery engineering assessment of the Turbine Lander. Pre-deployment characterization efforts yielded a peak power coefficient of approximately 0.3 for the rotor, although system losses resulted in much lower water-to-wire efficiencies under most operating conditions. The results demonstrate the importance of co-design among key components of the powertrain and control systems to achieve acceptable system efficiency across operating conditions.

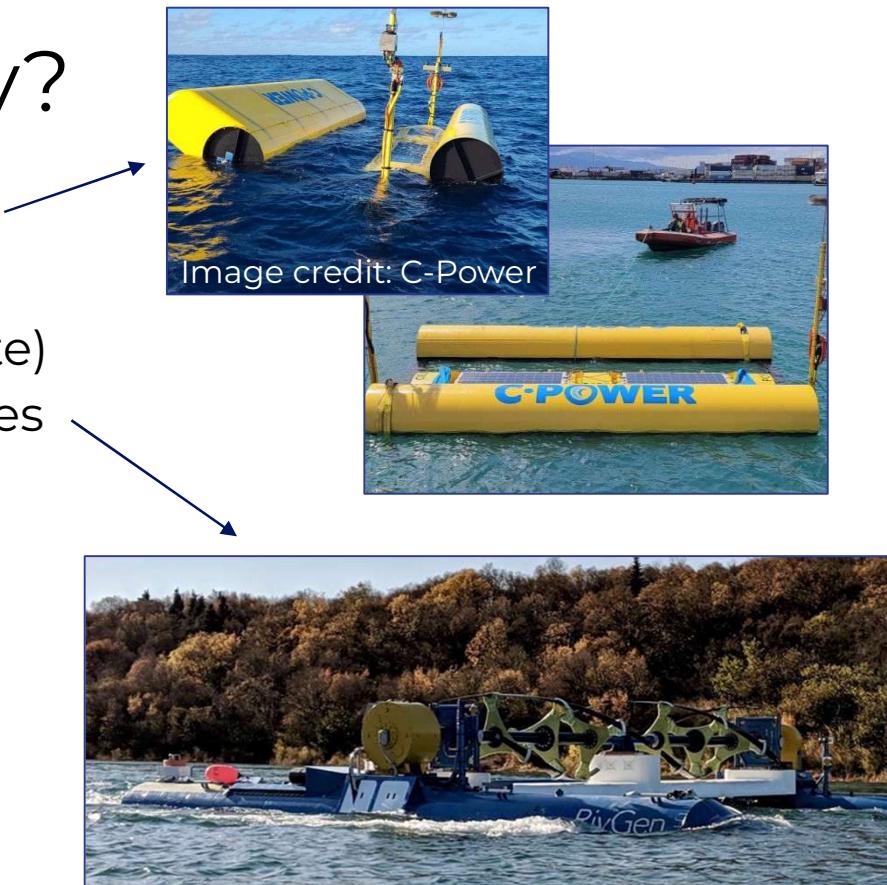
Ocean Renewable Power Company RivGen Turbine.
Igiugig, AK. Photo: NOAA

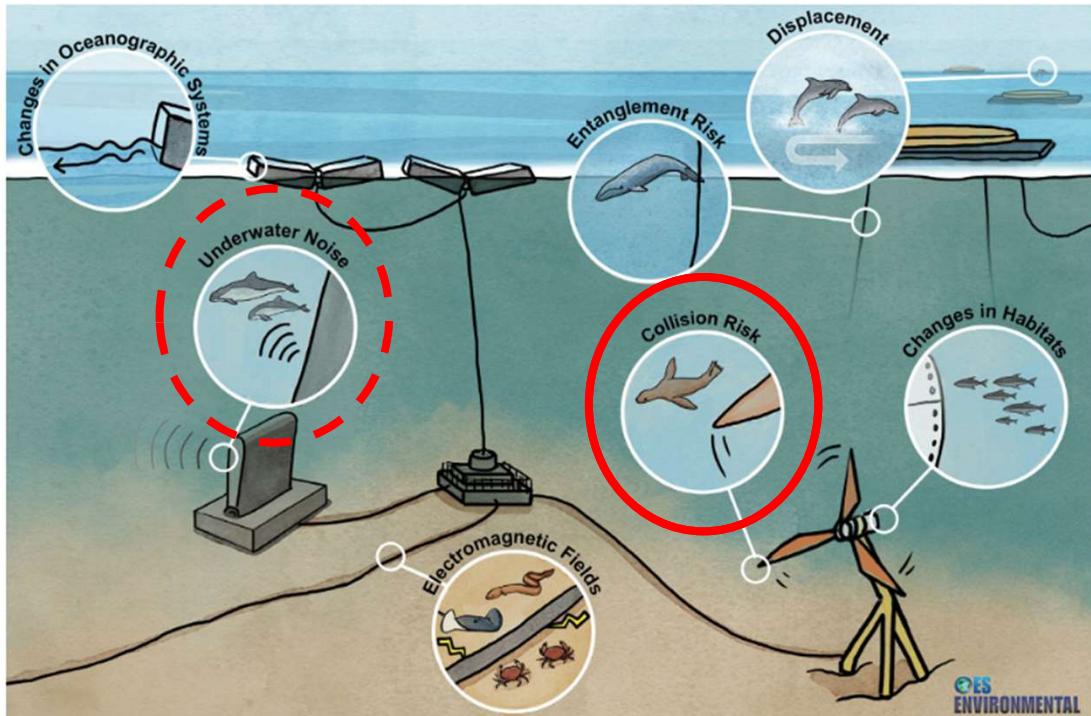
Figure 1.2. Stressor-receptor interactions potentially arising from various marine renewable energy devices. (Illustration by Stephanie King)

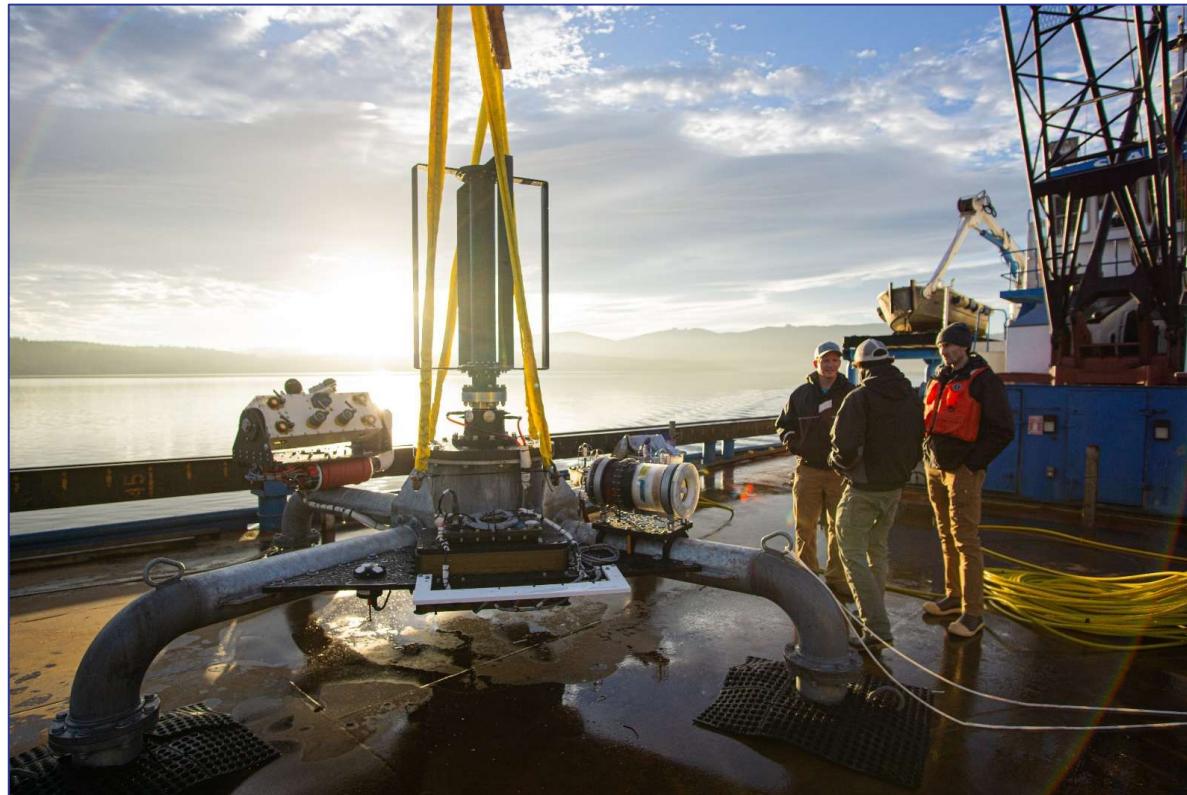
Total size:
4 m x 4 m x 2.7 m

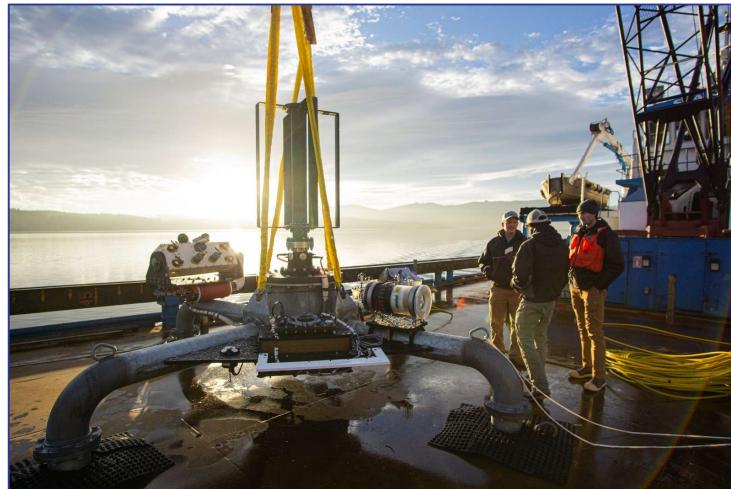
Case Study: The Turbine Lander

- A turbine this size might generate 100 W (on average)
- This is little power on land, but at sea this can significantly enhance our ability to use advanced sensing package, increase telemetry, or change vehicles remotely.

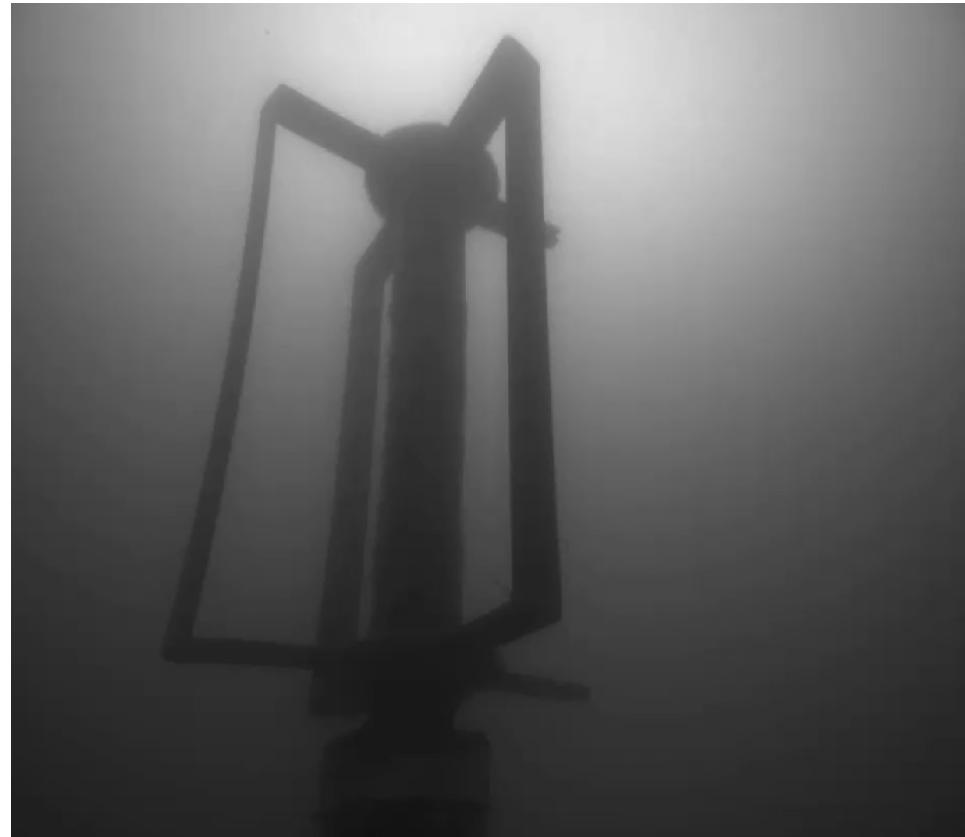
All observations during day

0 observations while turbine was rotating

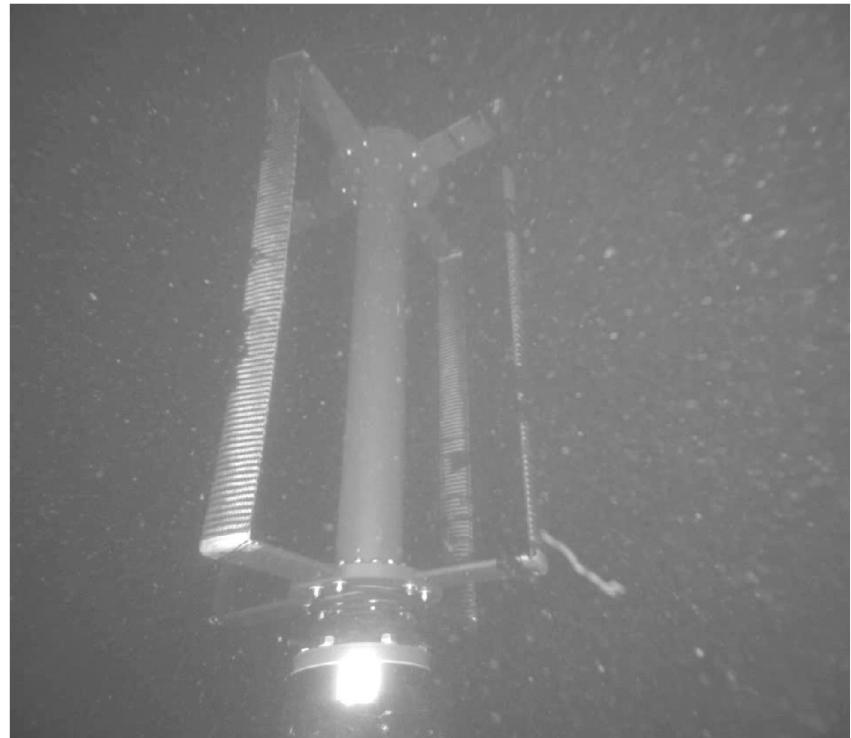
1 fish, passively drifting with flow and collided with the turbine while it was stationary (seal in sonars).

All collisions with small fish (less than ~6 in)

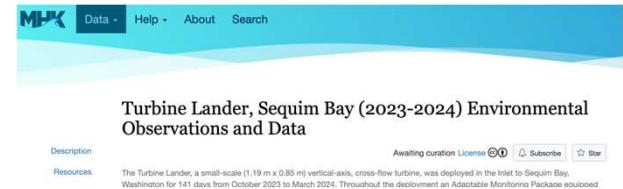
The screenshot shows a web page from the MHK Data portal. The header includes the MHK logo and links for Data, Help, About, and Search. The main content area is titled "Turbine Lander, Sequim Bay (2023-2024) Environmental Observations and Data". It features a "Description" section and a "Resources" section. The "Resources" section contains a link to a PDF document titled "The Turbine Lander, a small-scale (1.19 m x 0.85 m) vertical-axis, cross-flow turbine, was deployed in the Inlet to Sequim Bay, Washington for 141 days from October 2023 to March 2024. Throughout the deployment an Adastral Monitoring Package sourced". There are also buttons for "Awaiting curation", "License", "Subscribe", and "Star".

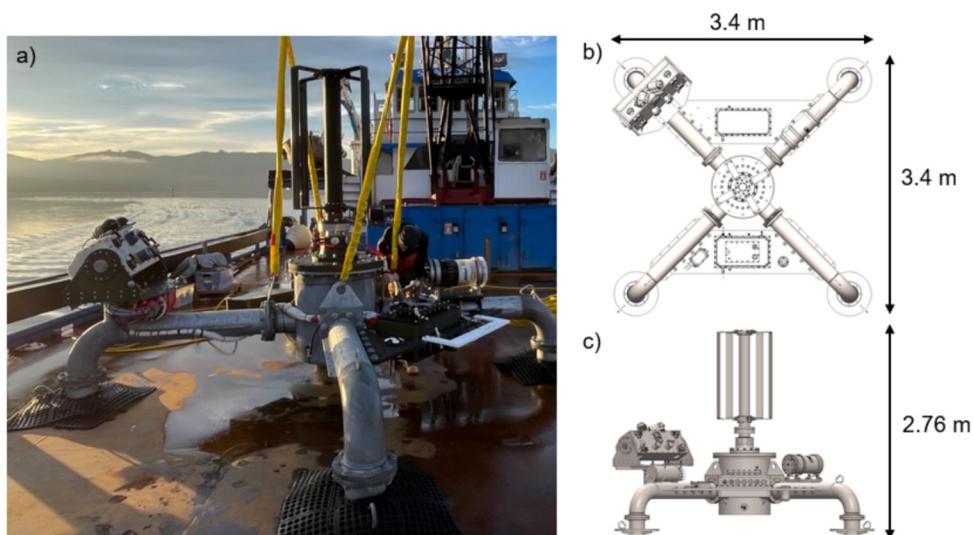
Fig. 1 **a** The Turbine Lander prepared for deployment in Sequim Bay, Washington. Plan **(b)** and elevation **(c)** views of the Turbine Lander showing its length, width, and height when fully assembled

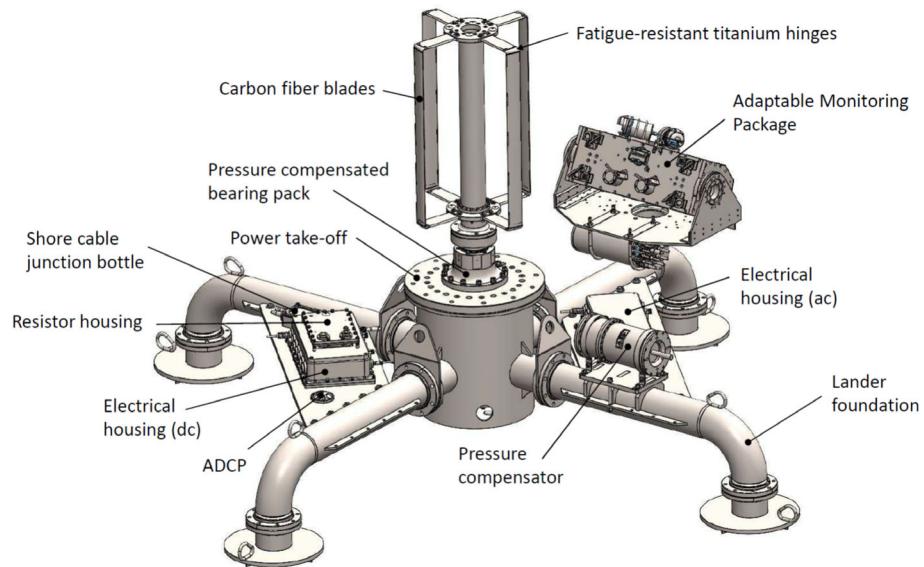
Fig. 2 A labeled rendering of the Turbine Lander lacking only the scour mats, hydrophone array, electrical cables, and hoses. The pear links welded to the foundation's legs and feet were included to facilitate assembly and deployment

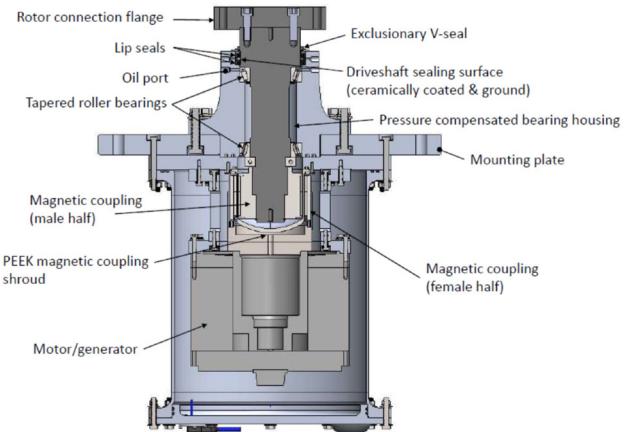
Fig. 3 A labeled rendering of the driveline assembly and generator housing

Two tapered roller bearings housed in an oil-filled chamber were used to maintain the shaft alignment while two lip seals and an exclusionary v-seal were used to isolate the bearings from salt water and particulate and to prevent lubrication oil egress into the environment. The lip seals can support a maximum pressure differential of 48 kPa relative to ambient conditions. Given the tidal range at the site (up to 3.8 m) and deployment depth, this required an oil-filled pressure compensator, which provided an additional 13.8–27.5 kPa of positive gauge pressure relative to ambient pressure at depth. A biodegradable oil (PANOLIN TURWADA SYNTH 46) was selected as the lubricant for the bearing pack in the event of a seal failure. The drive shaft's sealing surface was coated with alumina-titania ceramic to increase the resistance to wear, which also reduces friction at the sealing surface. A labeled rendering of the driveline and generator housing is included in Fig. 3.

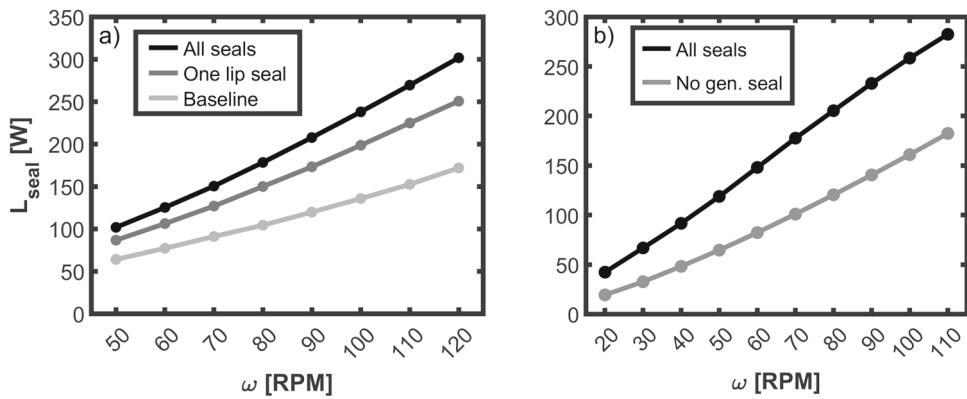
Fig. 4 **a** Measurements of baseline and seal-related system losses. “All seals” curve represents the total losses measured including baseline operations, both lips seals, and the v-seal. **b** A comparison between system losses with both lips seals and the v-seal installed when the

The results of these tests (Fig. 4a) show that baseline losses for the system range from approximately 60 to 120 W for operating conditions from 50 to 100 RPM. Installing a second seal increases losses by approximately 30 W at 50 RPM and close to 80 W at 120 RPM. The addition of the final lip seal and v-seal resulted in total frictional losses ranging from 100 to 300 W. Increases in power input requirements correspond to parasitic torques of 3–5 N m with the addition of each seal. While relatively small, these losses values are not insignificant near cut-in speed and represent the cost of balancing survivability with power generation.

The baseline conditions include a dust seal on the manufacturer's generator housing. As part of the post-deployment review, we performed additional testing without that seal and found this to reduce parasitic torque by approximately 10 N m, which translates to losses of 50–120 W across operating states (Fig. 4b). This seal, therefore, constituted an unexpectedly high fraction of the baseline losses.

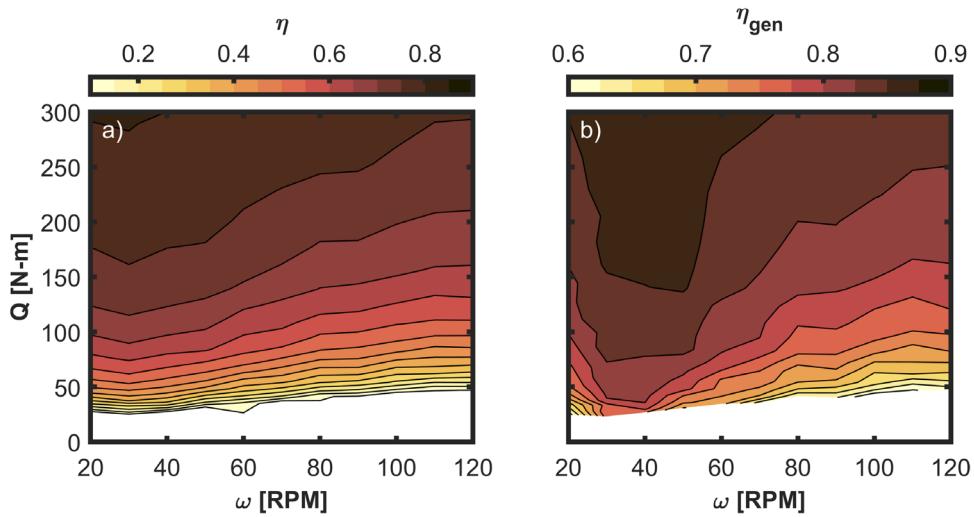
Fig. 5 Results from the dynamometer measurements. **a** PTO efficiency estimated as P_e/P_m . **b** Estimates for η_{gen} using Eq. 7, which accounts for mechanical losses. The y-axis is the torque input to the driveshaft

as measured by the torque cell. This can be used to estimate the control torque at the same operating state by subtracting 20 N m, which is an approximation to the baseline parasitic torque present in the system

net positive power generation, with peak $\eta_{\text{ww}} < 10\%$. This is a consequence of low PTO efficiency under these conditions (Fig. 5a). Optimal tip-speed ratios decreased slightly and η_{ww} exceeded 20% when inflow speeds were 2 m/s or greater. Phase-resolved (4° resolution) control torque, power, and efficiency (see supplemental material) were consistent with a priori expectations and yielded no significant signs of fabrication or assembly issues (e.g., deviations from expected periodicity due to alignment issues).

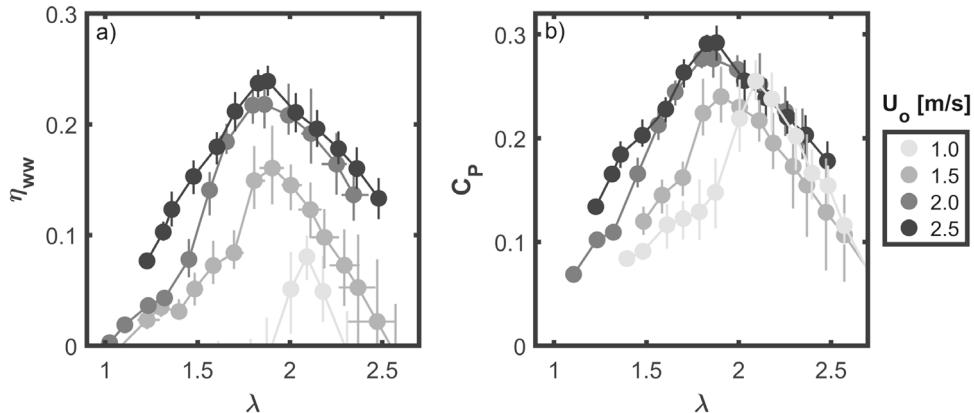
Fig. 6 **a** Water-to-wire efficiency versus tip-speed ratio as a function of inflow speed from 1 to 2.5 m/s. **b** C_P using control torque and seal loss measurements (Eq. 8). The mean and 5–95th percentile bounds for the tip-speed ratios in (a) and (b) are calculated from the rotational speed

Results for the time-averaged water-to-wire efficiency and electrical power generation under test conditions are shown in Fig. 6. At inflow speeds of 1 m/s, $\lambda > 2$ is required for

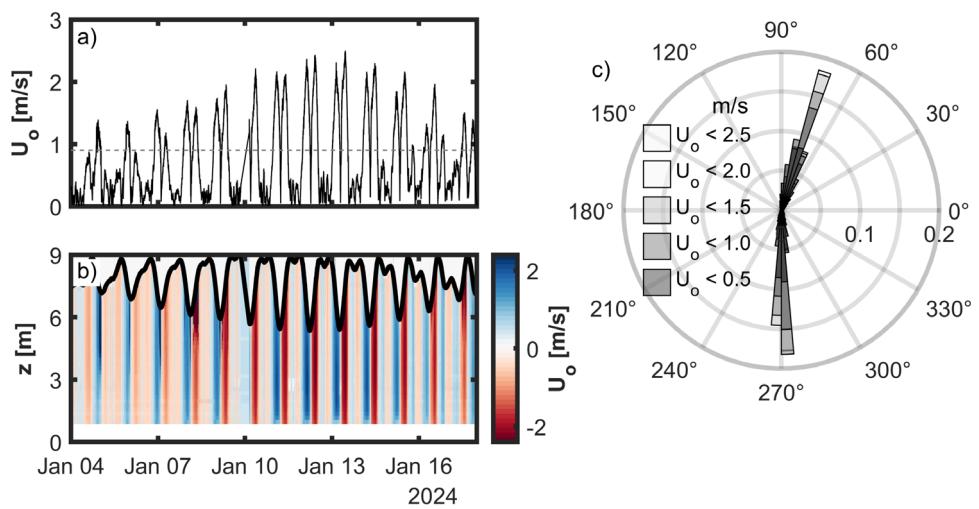
Fig. 8 **a** Measured tidal currents 3.1 m above the seabed. The dashed line shows the cut-in speed. **b** Profiles of tidal currents for the same period shown in **a**. The black line tracks the surface. **c** Probability density functions for inflow velocity and direction. Note that this period includes some of the strongest exchanges expected in a given 1-year period

As shown in Fig. 8, the site's mixed semi-diurnal tides result in periods of 12–18 h each day when currents are too weak for power generation, while the spring-neap cycle drives significant variability in peak currents associated with a given day's largest exchanges. Peak currents were nearly 2.5 m/s during both ebb and flood tides, but are not representative of the general conditions at the site. Vertical shear corresponding to approximately 10% of the mean current measured at 3.1 m was regularly observed across the depths spanned by the rotor (see the supplemental material). In addition, post-deployment analysis of the flood tide boundary layer suggests that mean inflow conditions averaged across the rotor height were typically on the order of 80–90% of the measured inflow at 3.1 m.

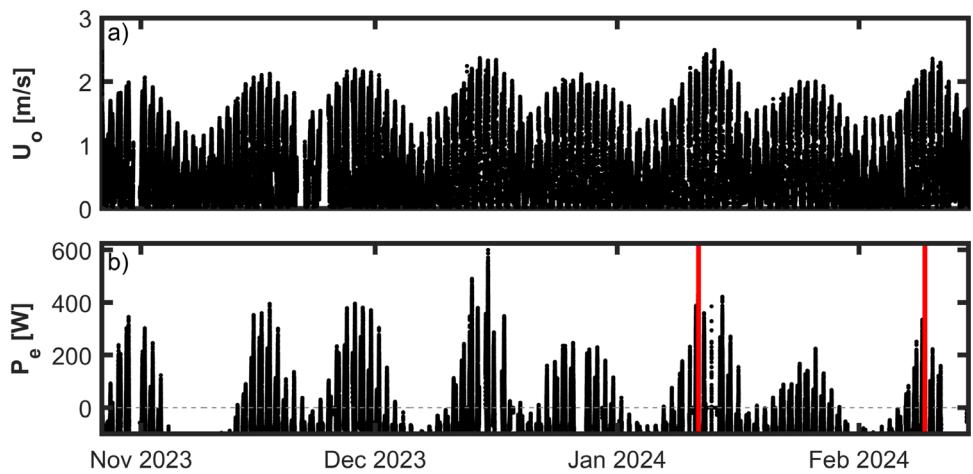
Fig. 9 **a** Reference inflow velocities (2-min average) measured 3.1 m above the seabed and **b** power generation (2-min average) throughout the deployment. In **b** the two vertical red lines correspond to the blade loss events. Note also that the figure includes periods where the system was operating at a net loss of power (i.e., power input was required to operate the rotor)

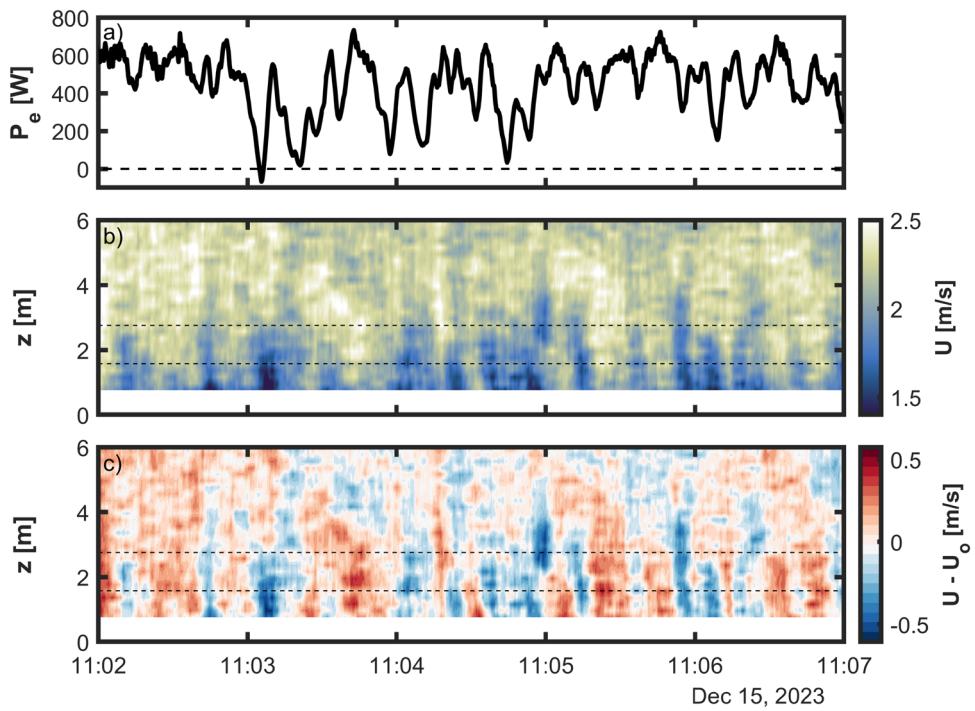
Fig. 10 **a** Turbine Lander electrical power generation calculated using a 6-s moving average. **b** Inflow velocity profiles using 6-s moving averages. The dashed black lines show the height of the bottom and top of the rotor. Over the 5-min period, there is a clear correlation between the generated power and the fluctuating velocities. **c** Velocity profiles show the deviations of the 6-s averages from the mean of all profiles shown in **b**

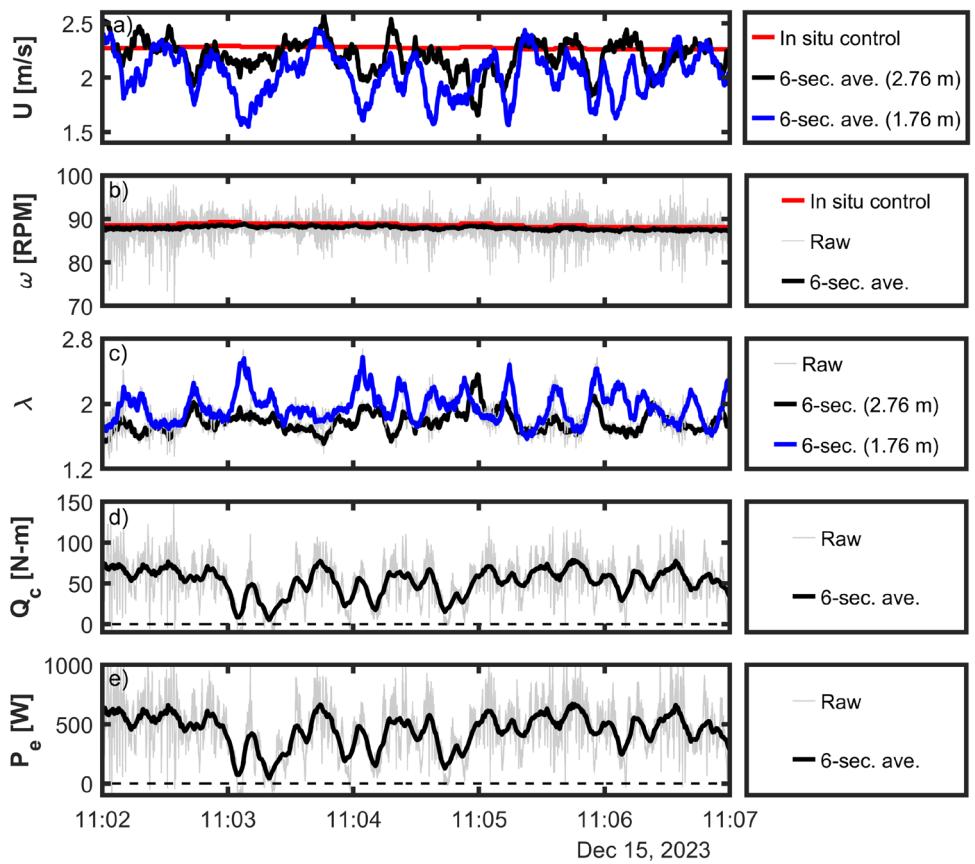
Fig. 11 **a** Inflow conditions (2-min and 6-s moving averages). Raw and 6-s averaged rotor speed (**b**), tip-speed ratios at the top and bottom of the rotor (**c**), control torque, and (**d**), electrical power. The data 2.76 m above the seabed correspond roughly to the top of the rotor while the data at 1.76 m are near the bottom of the rotor. Raw data were sampled at 100 Hz. All subplots correspond to the same time periods in Fig. 10

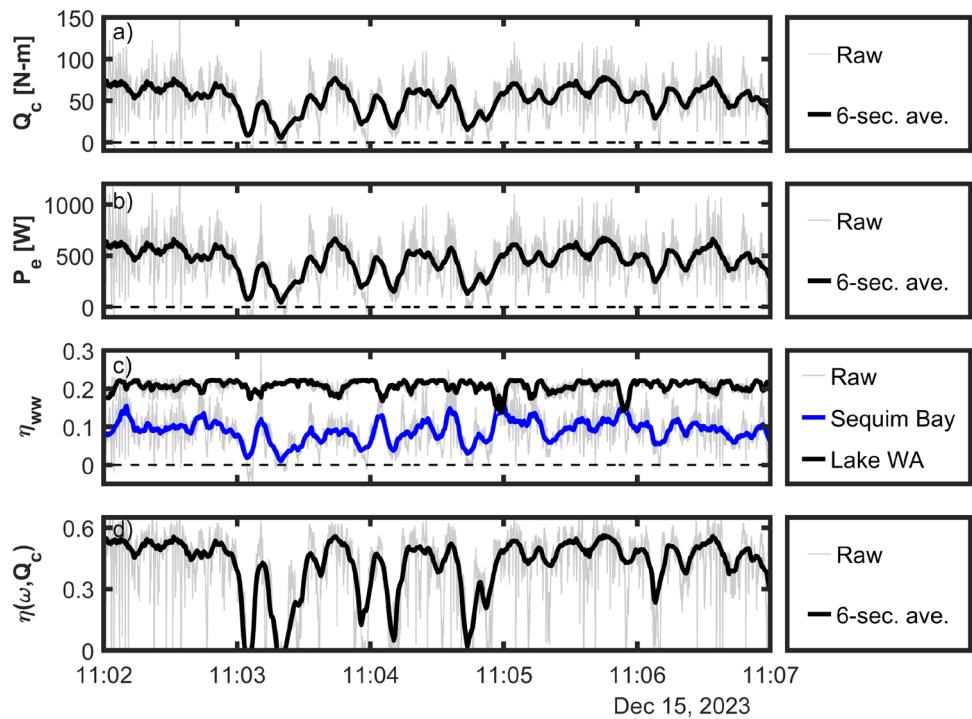
Fig. 12 Raw and 6-s averaged control torque (a) and electrical power (b). c Wire-to-water efficiencies as a function of time. The black line shows the expected η_{ww} based on the vessel-based measurements (Fig. 6) given the averaged inflow velocities and rotor speeds (Fig. 11a–b). The blue line shows the wire-to-wire efficiencies calculated from the electrical power and inflow velocities. d Estimates of PTO efficiency interpolated from the dynamometry data for the measured rotor speed and control torque after accounting for frictional losses (Fig. 5a). All subplots correspond to the same time periods in Figs. 10 and 11. The differences between the lines in c are attributed to a combination of biofouling, operational inefficiencies, and the spanwise variations in λ across the blades due to shear in the water column

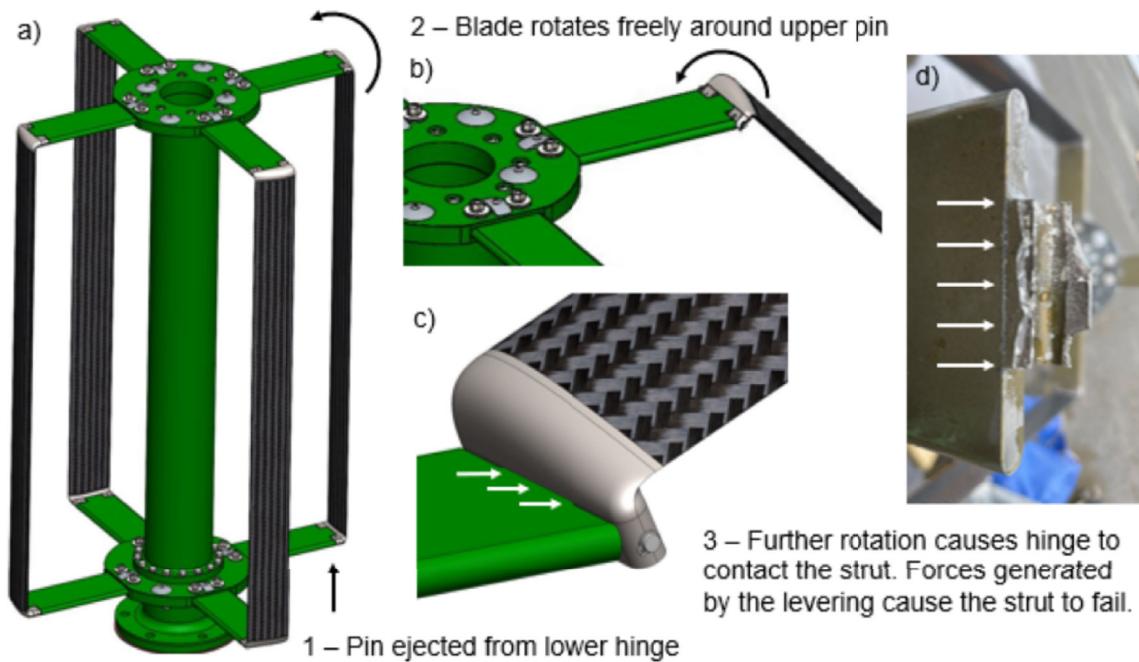
Fig. 13 **a** A drawing of the intact rotor with blades installed in their proper positions. **b** With the lower pin missing, the foil can rotate around the upper pin. **c** If the foil rotates greater than 90° degrees the titanium hinge eventually contacts the strut. **d** A picture of one strut with a missing foil. Note the damage to the anodized surface of the strut where the

This mode of failure points to a design flaw that needs to be addressed in future systems. Poor tolerances in the 3D-

printed titanium hinges, despite post-machining the parts, may have attributed to this failure by allowing some wobble under load. The design and layup of the composite blades to reduce stress concentrations at the hinge is also complicated. A redesign of this entire system should include a more robust mechanism to retain fasteners and could decrease manufacturing costs.

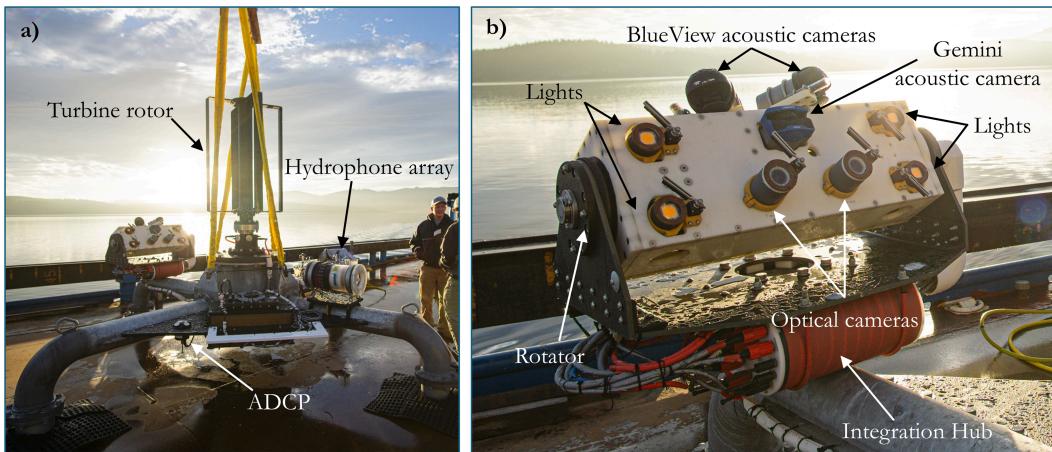
Fig 1. Turbine and monitoring equipment. (a) The Turbine Lander prepared for deployment. (b) The Adaptable Monitoring Package instrument head with sensors annotated. Photo credit: Abigale Snortland.

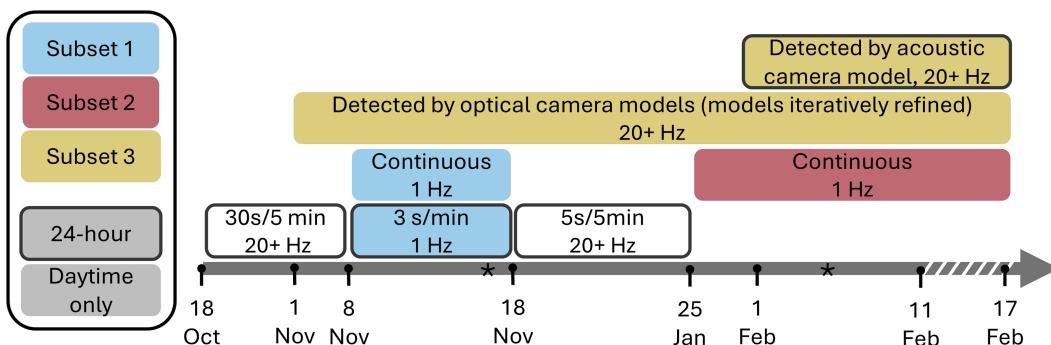
Fig 3. Timeline summarizing data collection. The three data subsets that were analyzed are indicated. Periods with a dark border include nighttime data, while periods without a dark border were only collected during daylight hours. Periods of data in white were not analyzed, and asterisks (*) indicate periods where the AMP was offline for up to 5 hours for system maintenance. The dashed portion of the timeline after 11 February indicates the period when the turbine was deployed, but not operating. Note that the timeline is not to scale.

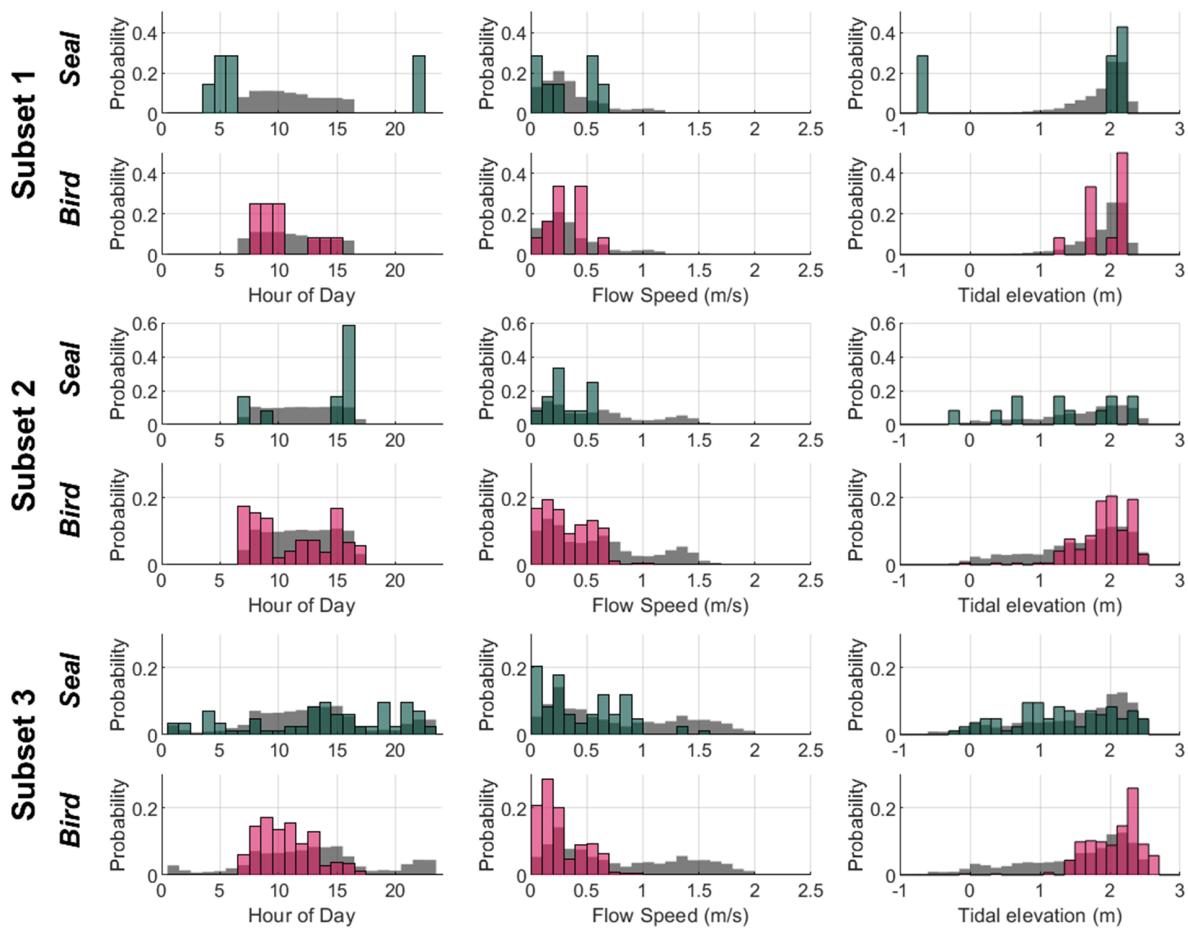
Fig 4. Distribution of seal and bird events. Distribution of events containing seals and seabirds in each data subset with respect to hour of day (local time), flow velocity, and tidal elevation (colored bars). Gray bars in the background of each histogram indicate the distribution of each environmental covariate throughout all images that were recorded and reviewed. Note that the y-axis scale differs between classes and data subsets.

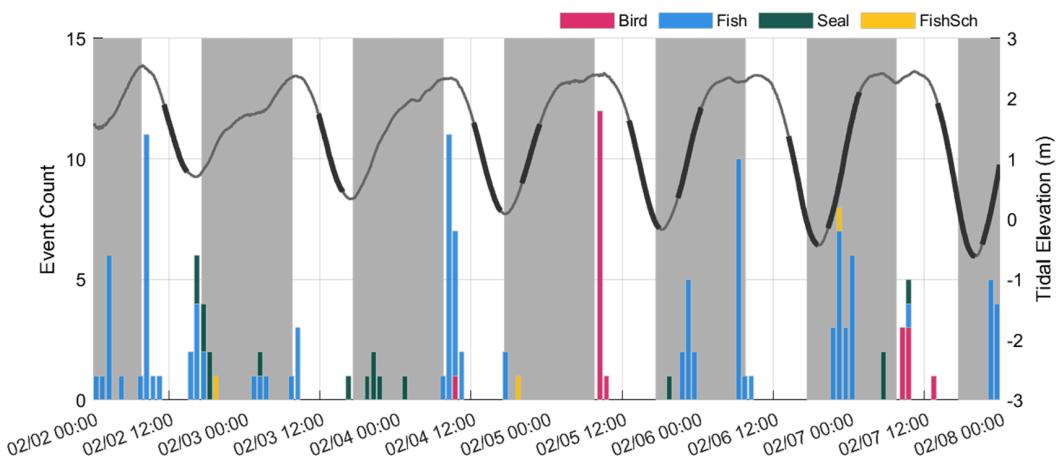
Fig 5. Representative timeseries of events. Number of events associated with each class per hour for a representative week of data. Events from both data subset 2 (continuous acquisition) and data subset 3 (detected events) are shown. Hours between sunset and sunrise are indicated in gray, and the tidal elevation is shown for reference. The darker regions of the tidal elevation time series indicate periods when the turbine was rotating.

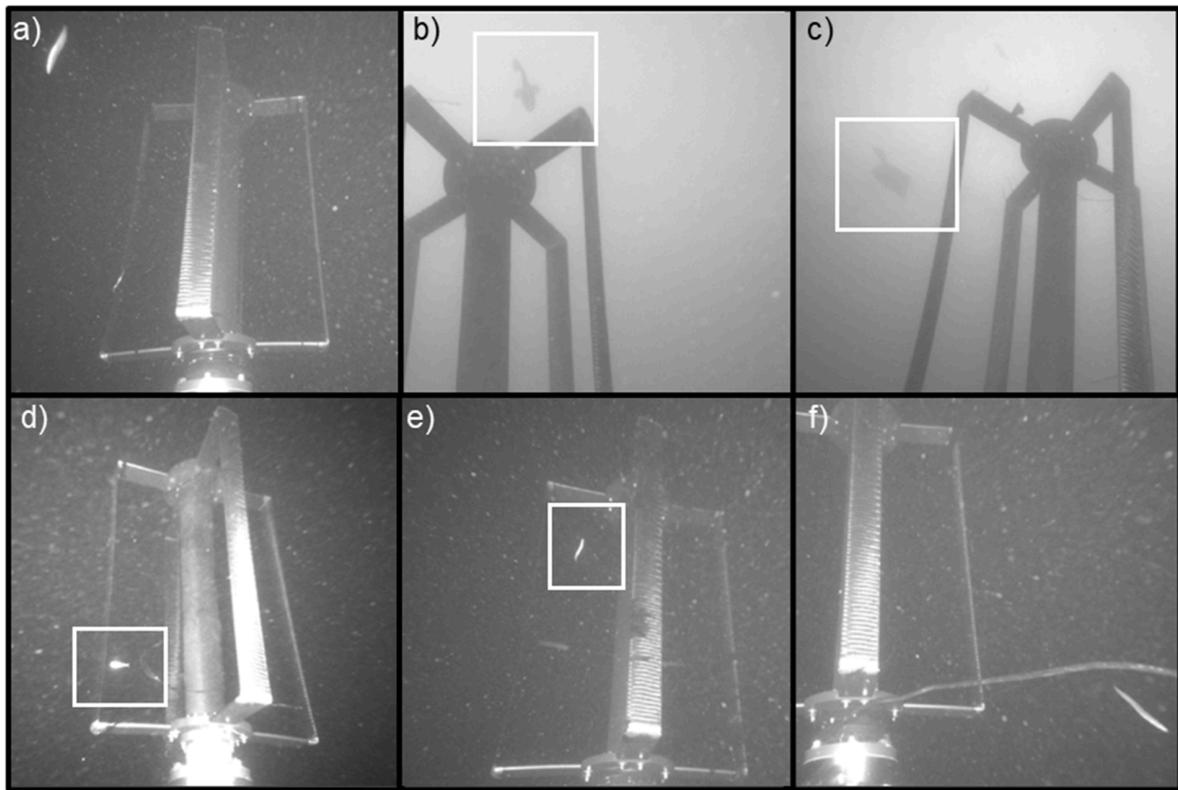
Fig 6. Examples of individual fish when the turbine was rotating. (a) Small fish drifting, head down, between AMP and rotor. (b) Large, unidentified fish swimming above rotor. (c) Flatfish drifting above moving rotor. (d) Perch-like species drifting with current between AMP and rotor. (e) Fish swimming within moving rotor. (f) Fish swimming away from rotor after collision.

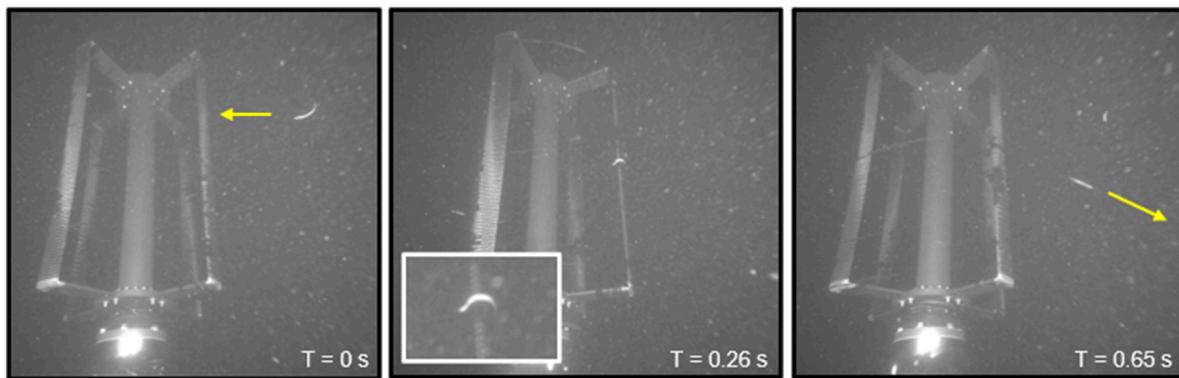
Fig 7. Example of a collision between a fish and the turbine blades. The yellow arrows approximate the direction the fish was moving in a given frame, and times are presented relative to the first frame. The inset in the middle frame shows a larger view of the collision seen on the blade on the right-hand side of the image.

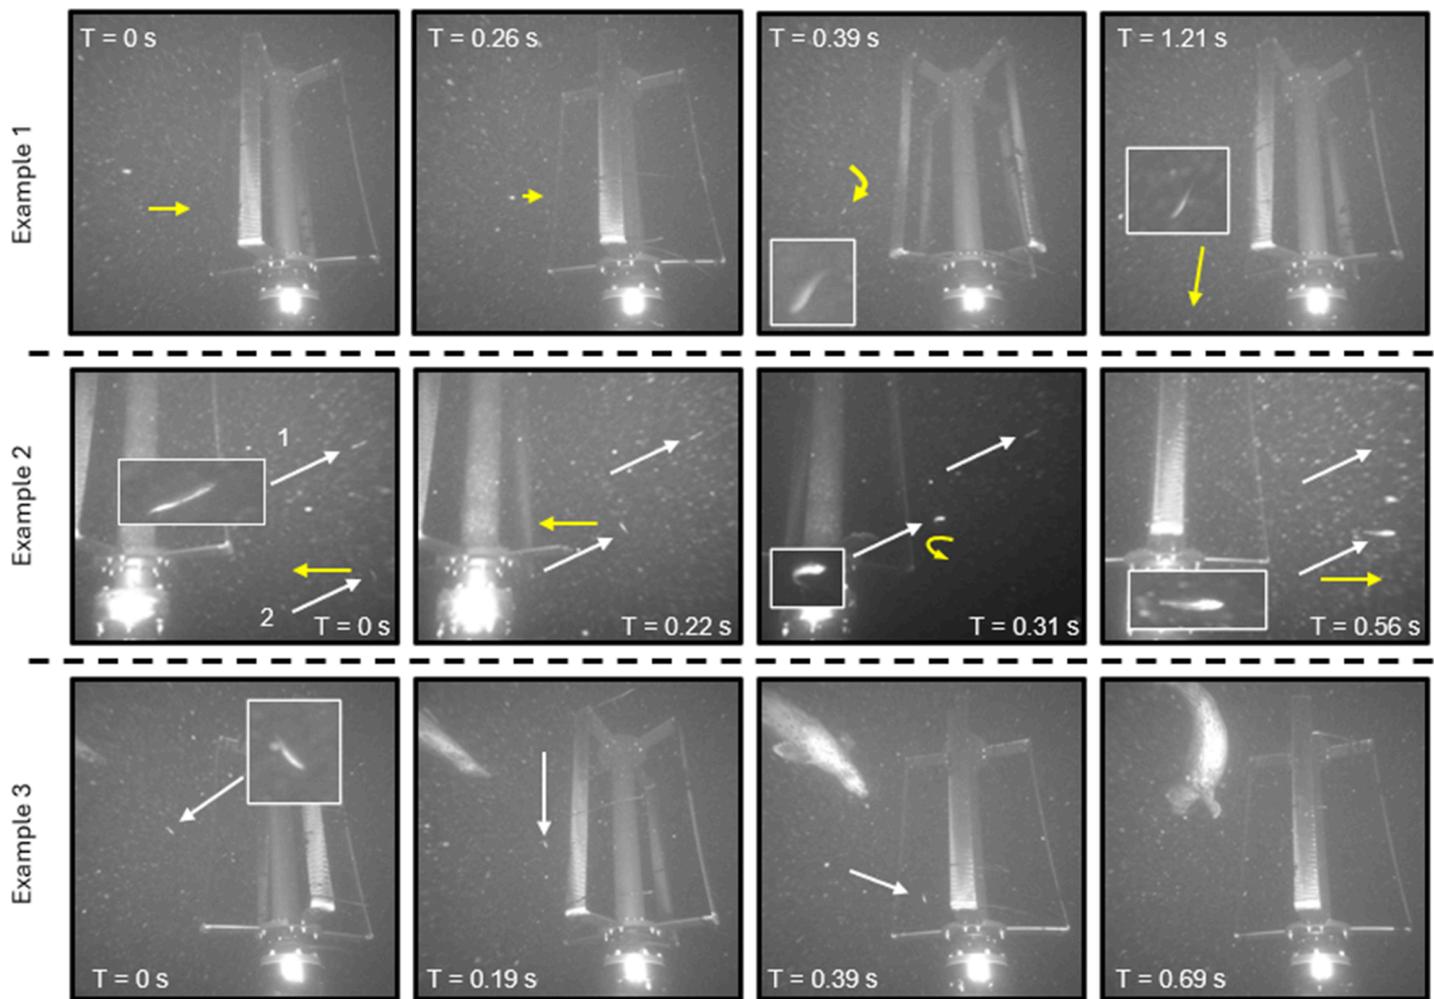
Fig 8. Examples of evasion events while the turbine was operational. In the images, the white arrows point to the fish and the yellow arrows approximate the direction of travel in optical images. Times are presented relative to the first frame. (Example 1) An evasion event with a single small fish. The fish approaches the rotor before turning and diving down away from the rotor. (Example 2) Two fish evading the turbine rotor using different tactics. Fish 1 swims against the current and moves out of the field of view. Fish 2, swimming with the current, executes a turn and swims away from the rotor. (Example 3) A seal pursuing a fish. The fish swims into and out of the rotor, evading a collision with the moving rotor in the process. As the seal approaches the moving rotor it stops pursuing the fish, slows down, and swims away from the rotor.

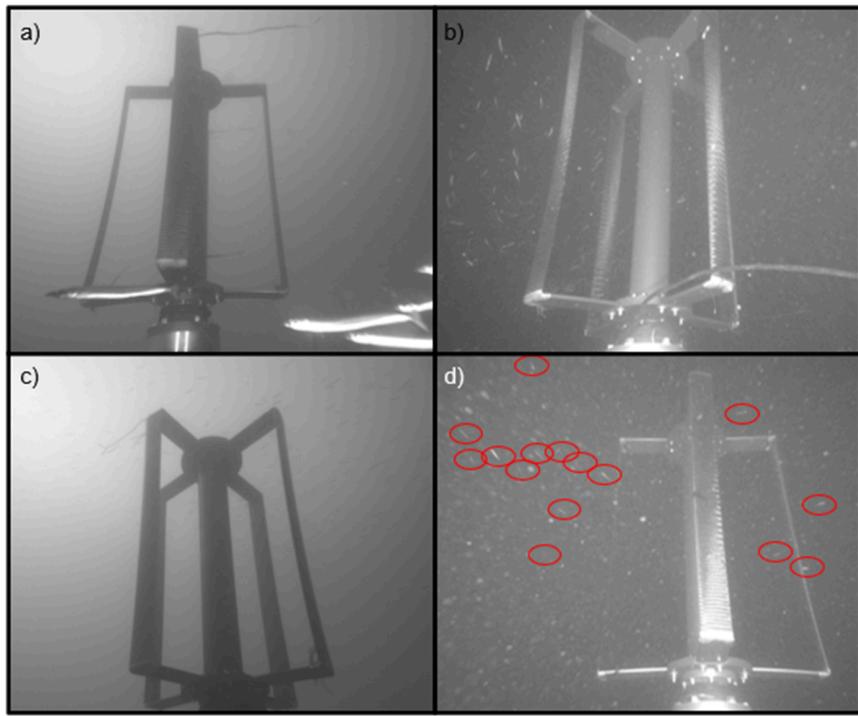
Fig 9. Examples of fish schools. (a–b) A small school of forage fish near the AMP. (b) A fish school near the rotor. Most fish swim up or around the backside of the rotor although several swim between the rotor and the camera. (c) A fish school near the surface while the turbine was stationary. (d) A fish school evading the turbine rotor at night while the turbine was rotating. Red circles highlight the individual fish.

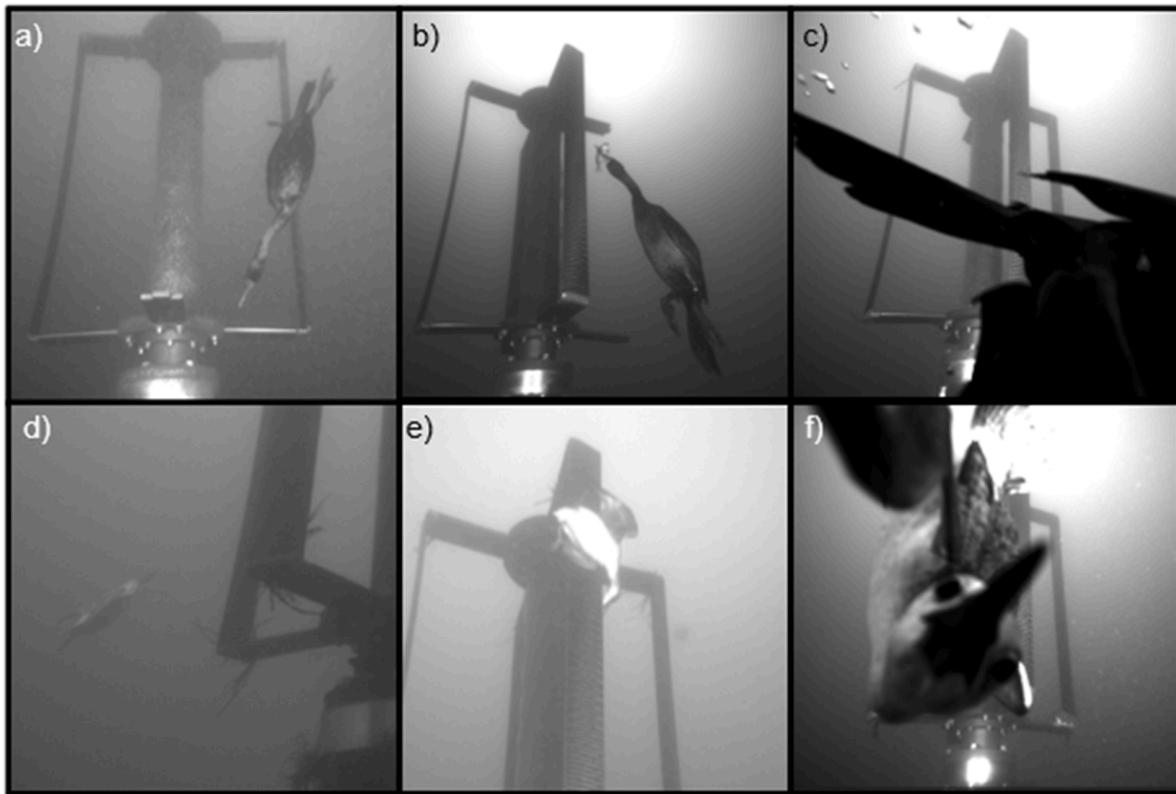
Fig 10. Examples of seabirds. (a–c) Cormorants diving, swimming to the surface, and presumably foraging in the vicinity of the AMP. (d–f) Pigeon guillemots swimming, picking at the rotor, and interacting with the AMP.

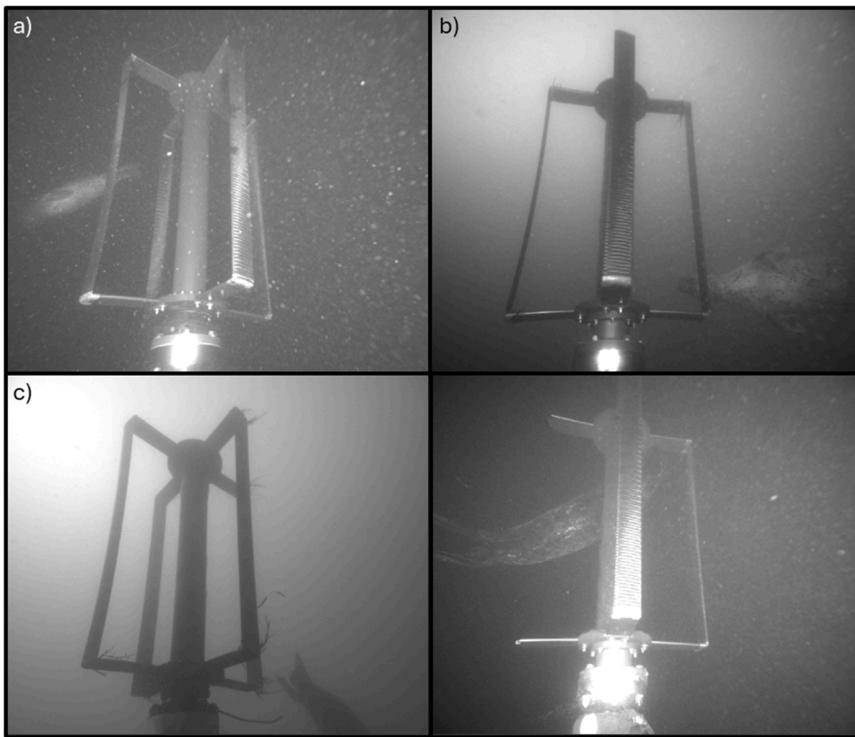
Fig 11. Examples of seals. a) Seal swimming behind the moving rotor at night. b) Seal approaching the moving rotor in the wake during the day. c) Seal diving towards the seabed. d) A seal entering the rotor's swept area and bending around the shaft. In both (c) and (d) the rotor was stationary.
